# SLIPPERY WHEN WET

*A new fouling release proves a sound choice for Jeanneau NC9 owners Harry and Vicki Metcalfe*  
*Words and photos Hugo Andreae*

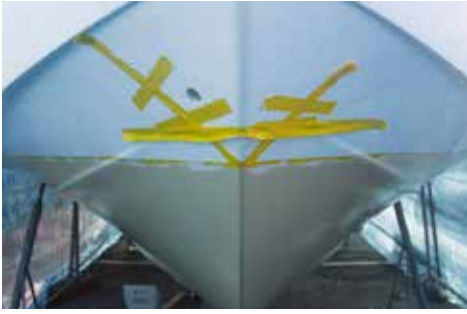
**1 PRIMER COAT** As a brand new boat *Fino's* gel coat needed to be sanded and washed before being given four coats of Hempel Light Primer. Previously antifouled boats only need one.

The application process was a little more complex than normal as it requires a special tie coat in addition to the usual two coats of primer and Silic One. And because it has to be completed in quite a specific time, temperature and humidity window, Landau had to use a tent and heaters to meet the parameters. Harry describes the finished result as "very smooth and surprisingly tough."

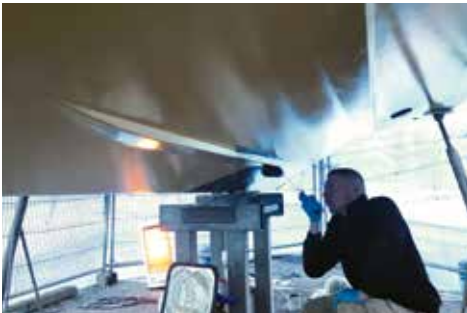
**3 SILIC ONE** Two coats of Silic One were used as this was the first application but if it needs refreshing one will suffice. Again it must be done within 48 hours of the tie coat application

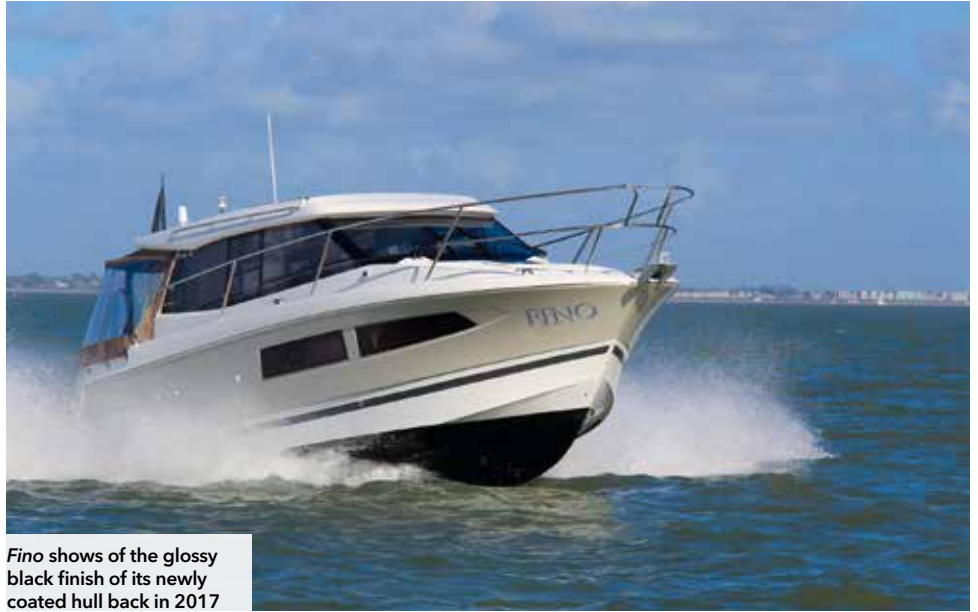
*Fino* shows of the glossy black finish of its newly coated hull back in 2017

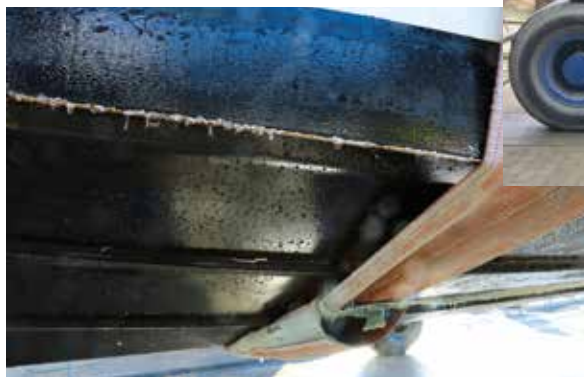
ABOVE After 15 months in the water the Silic One coated hull looks remarkably clean but the untreated drive and trim tabs are heavily fouled LEFT A quick spray down to remove the slime and *Fino's* hull looks ready for a third season. Note how the water beads on the hydrogel surface

When their boat was finally lifted in January this year MBY was there to witness it and sure enough it was a similar story with long trails of weed hanging off the trim tabs and a thick crust of barnacles on the sterndrive but only a thin coating of slime on the hull sides and almost nothing on the underside, except for where the hull had been blocked off during the initial application. The slime wiped off with a tissue and even the occasional calcified tubeworm could be dislodged with nothing more than a thumb nail. After the usual spray down, with the
